# Access Compliance Report Public Rights-of-Way (Island Curb Cuts)

| Main Street:N_SELLAS_RD | | Cross Street:N_SELLAS_RD | | Location: | SE |
| ADA ID: CCRK211109130320 | Curb Cut Type:MedianRefuge2 | Initial Pass/Fail: Pass | Overall Compliance: No | Severity Score: | 15 |

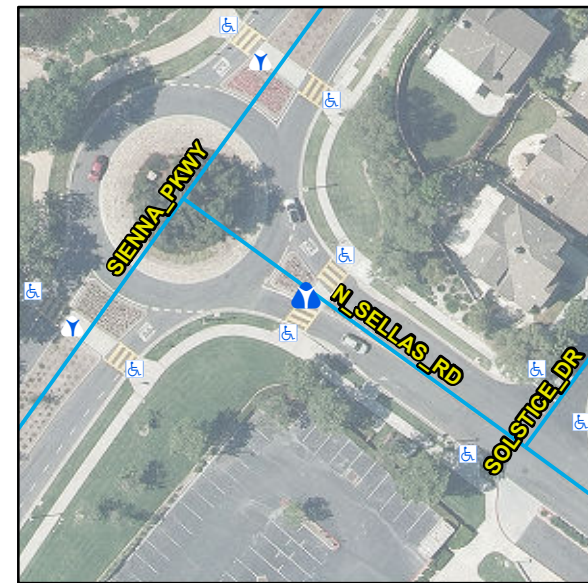
| Compliance | Description | Data | Compliance | Description | Data |
|---|---|---|---|---|---|
| N/A | Painted Cross Walk 1 | Yes | No | DWS 1 Provided | No |
| N/A | Painted Cross Walk 2 | Yes | No | DWS 2 Provided | No |

Possible Solutions:

Install Detectable Warning System.
