# Access Compliance Report Public Rights-of-Way (Island Curb Cuts)

| Main Street:N_DAISSY_ST | | Cross Street:SIENNA_PKWY | | Location: | E |
| ADA ID: CCRK211110125423 | Curb Cut Type:MedianRefuge2 | Initial Pass/Fail: Pass | Overall Compliance: No | Severity Score: | 15 |

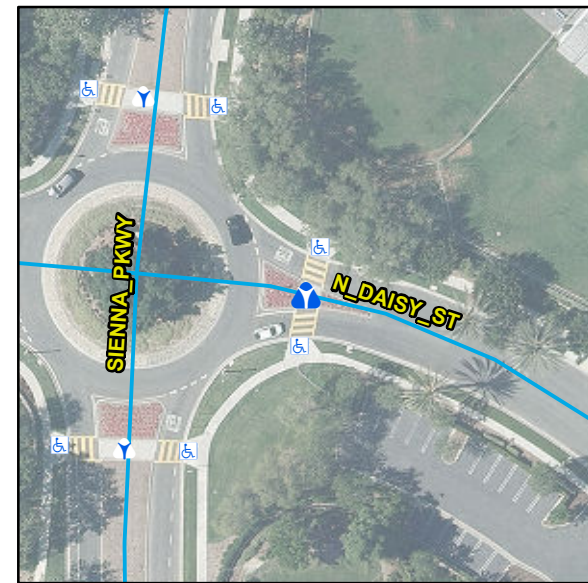
| Compliance | Description | Data | Compliance | Description | Data |
|---|---|---|---|---|---|
| N/A | Painted Cross Walk 1 | Yes | No | DWS 1 Provided | No |
| N/A | Painted Cross Walk 2 | Yes | No | DWS 2 Provided | No |

Install Detectable Warning System.
