# Access Compliance Report Public Rights-of-Way (Island Curb Cuts)

| Main Street: SIENNA_PKWY | | Cross Street: SIENNA_PKWY | | Location: | N |
| ADA ID: CCRK211110130303 | Curb Cut Type: MedianRefuge2 | Initial Pass/Fail: Pass | Overall Compliance: No | Severity Score: | 15 |

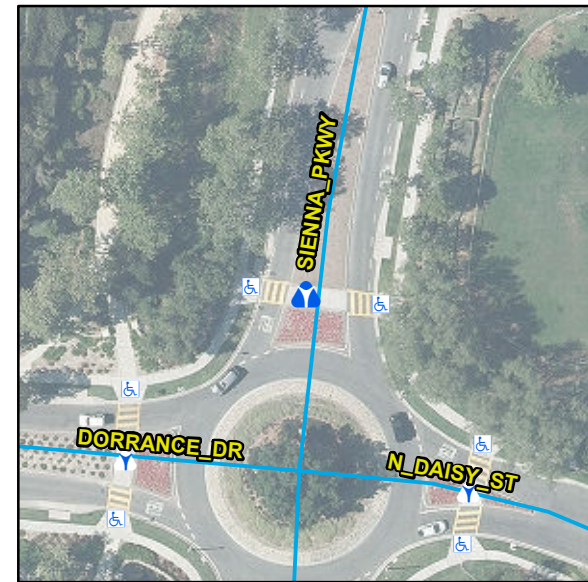
| Compliance | Description | Data | Compliance | Description | Data |
|---|---|---|---|---|---|
| Yes | Refuge 1 Length (In) | 107 | Yes | Guttter 1 Ponding | No |
| N/A | Painted Cross Walk 1 | Yes | No | DWS 1 Provided | No |
| Yes | Refuge 2 Cross Slope (%) | 3.5 | No | Gutter 2 Cross Slope (%) | 2.6 |
| N/A | Painted Cross Walk 2 | Yes | No | DWS 2 Provided | No |

Install Detectable Warning System. Remove & Replace Gutter.
