# Access Compliance Report Public Rights-of-Way (Island Curb Cuts)

Main Street: SIENNA\_PKWY Cross Street: SIENNA\_PKWY Location: SW

ADA ID: CCRK211111124659 Curb Cut Type: MedianRefuge2 Initial Pass/Fail: Pass Overall Compliance: No Severity Score: 0

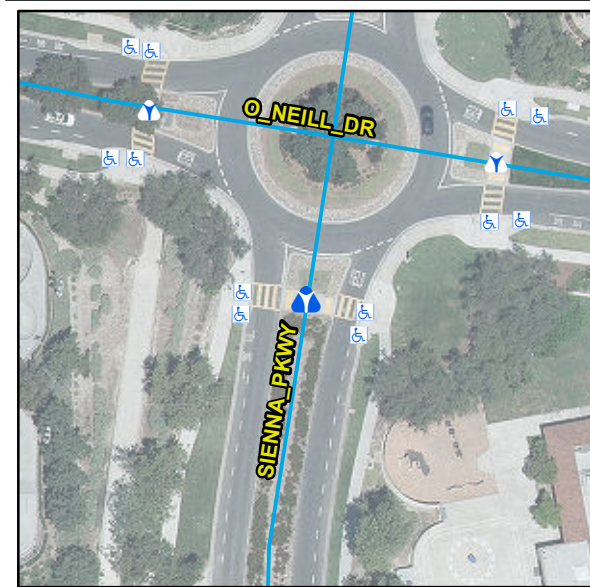
| Compliance | Description | Data | Compliance | Description | Data |
|---|---|---|---|---|---|
| Yes | Refuge 1 Cross Slope (%) | 1.9 | No | Gutter 1 Cross Slope (%) | 3.9 |
| | Road 1 Slope (%) | 4.5 | No | DWS 1 Offset (In) | 24 |
| Yes | Refuge 2 Cross Slope (%) | 1.8 | No | Gutter 2 Cross Slope (%) | 2.5 |
| | Road 2 Slope (%) | 0.7 | No | DWS 2 Offset (In) | 24 |

Possible Solutions:  
**Remove & Replace Detectable Warning System.  
Remove & Replace Gutter.**

OC Std/PROW:  
**R305.2, R304.5.3, STD 1115**
