# Access Compliance Report Public Rights-of-Way (Island Curb Cuts)

Main Street: O\_NEILL\_DR Cross Street: O\_NEILL\_DR Location: NW

ADA ID: CCRK211111131346 Curb Cut Type: MedianRefuge2 Initial Pass/Fail: Fail Overall Compliance: No Severity Score: 30

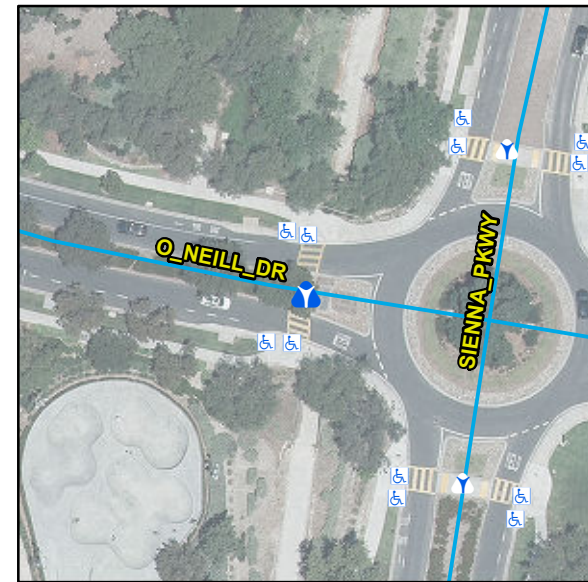
| Compliance | Description | Data | Compliance | Description | Data |
|---|---|---|---|---|---|
| No | Refuge 2 Slope (%) | 10.1 | N/A | Gutter 2 Slope (%) | N/A |

Remove & Replace Entire Refuge.

R302.5, STD 1115
