# Access Compliance Report Public Rights-of-Way (Island Curb Cuts)

Main Street: S\_SELLAS\_RD Cross Street: S\_SELLAS\_RD Location: SE

ADA ID: CCRK211111133940 Curb Cut Type: MedianRefuge2 Initial Pass/Fail: Fail Overall Compliance: No Severity Score: 30

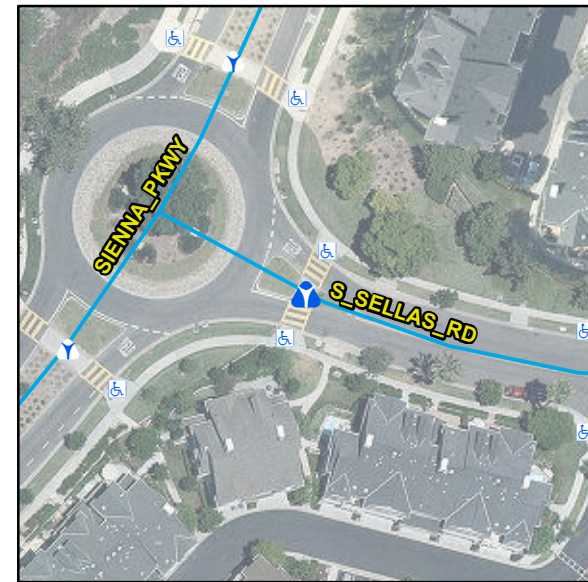
| Compliance | Description | Data | Compliance | Description | Data |
|---|---|---|---|---|---|
| No | Refuge 1 Slope (%) | 7.7 | N/A | Gutter 1 Slope (%) | N/A |
| No | Refuge 2 Slope (%) | 6.9 | N/A | Gutter 2 Slope (%) | N/A |

Remove & Replace Entire Refuge.
