# Access Compliance Report Public Rights-of-Way (Island Curb Cuts)

| Main Street: NARROW_CANYON_RD | | Cross Street: NARROW_CANYON_RD | | Location: | S |
| ADA ID: CCRK211115130034 | Curb Cut Type: MedianRefuge2 | Initial Pass/Fail: Pass | Overall Compliance: No | Severity Score: | 15 |

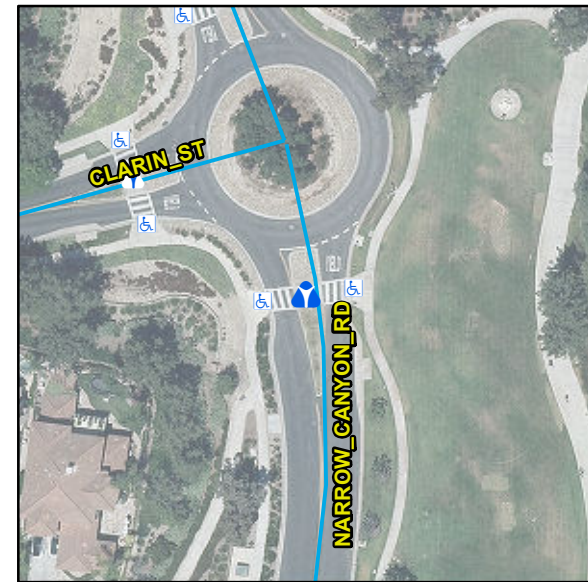
| Compliance | Description | Data | Compliance | Description | Data |
|---|---|---|---|---|---|
| Yes | Refuge 1 Cross Slope (%) | 2.9 | No | Gutter 1 Cross Slope (%) | 3 |
| N/A | Painted Cross Walk 1 | Yes | No | DWS 1 Provided | No |
| Yes | Refuge 2 Cross Slope (%) | 3.3 | No | Gutter 2 Cross Slope (%) | 2.8 |
| N/A | Painted Cross Walk 2 | Yes | No | DWS 2 Provided | No |

Possible Solutions:

Install Detectable Warning System. Remove & Replace Gutter.
