## **Access Compliance Report Public Rights-of-Way** (Island Curb Cuts)

Cross Street:O\_NEILL\_DR Main Street: O NEILL DR Location: W ADA ID: CCRK211115133232 Curb Cut Type: MedianRefuge2 **Initial Pass/Fail: Pass Overall Compliance: No Severity Score:** 15

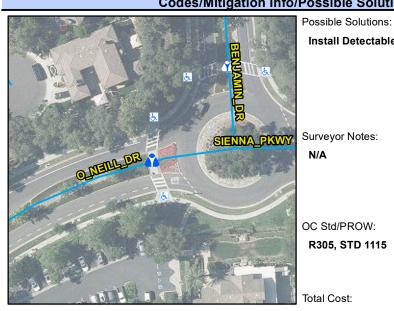
N/A	Painted Cross Walk 2	Yes	No	DWS 2 Provided	No			
		Cross Walk 2 Direction	N	N/A	DWS 2 Contrast	N/A			
2		Cross Walk 2 Width (In)	144	N/A	DWS 2 Length (In)	N/A			
	Yes	Refuge Inside Cross Walk 2	Yes	N/A	DWS 2 Full Width	N/A			
2		Road 2 Slope (%)	2	N/A	DWS 2 Offset (In)	N/A			
١.		Road 2 Cross Slope (%)	2.2						
	Yes	Overall Surface Condition: Acce	ptable

Install Detectable Warning System.
