# Access Compliance Report Public Rights-of-Way (Island Curb Cuts)

| Main Street: CORPORATE_DR | | Cross Street: CORPORATE_DR | | Location: | W |
| ADA ID: CCRK211116122844 | Curb Cut Type: MedianRefuge2 | Initial Pass/Fail: Fail | Overall Compliance: No | Severity Score: | 12.5 |

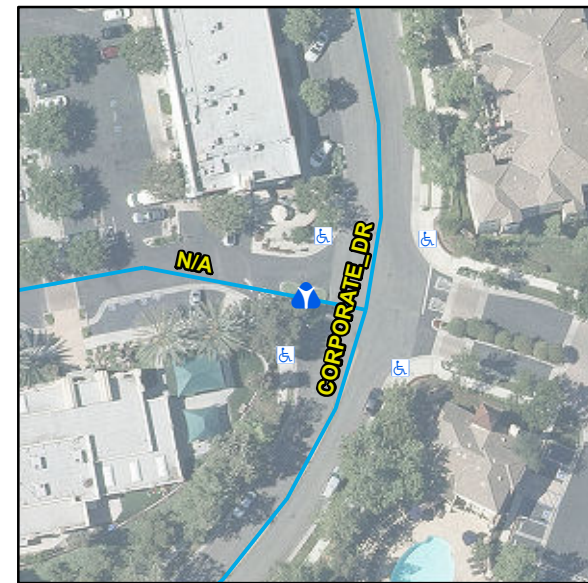
| Compliance | Description | Data | Compliance | Description | Data |
|---|---|---|---|---|---|
| No | Refuge 1 Width (In) | 46 | Yes | Gutter 1 Lip Ht (In) | 0 |
| No | Refuge 2 Width (In) | 46 | Yes | Gutter 2 Lip Ht (In) | 0 |

**Remove & Replace Entire Refuge.**

**R302.3.1, STD 1115**

Total Cost: \$ 5000
