# Access Compliance Report Public Rights-of-Way (Island Curb Cuts)

| Main Street: REATA_RD | | Cross Street: REATA_RD | | Location: | N |
| ADA ID: CCRK211118132534 | Curb Cut Type: MedianRefuge2 | Initial Pass/Fail: Pass | Overall Compliance: No | Severity Score: | 15 |

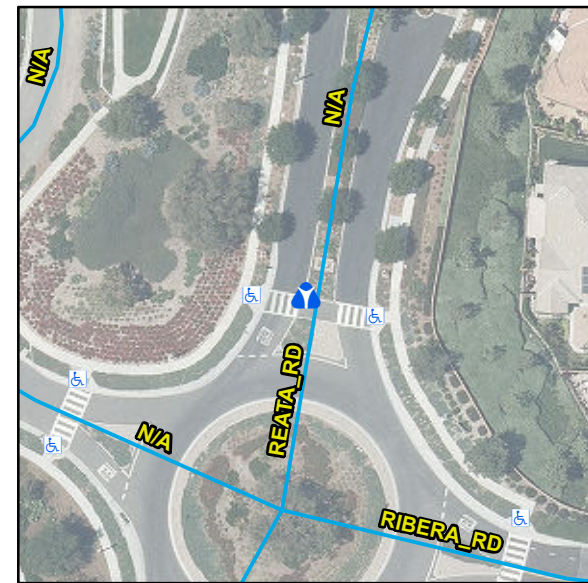
| Compliance | Description | Data | Compliance | Description | Data |
|---|---|---|---|---|---|
| N/A | Painted Cross Walk 1 | Yes | No | DWS 1 Provided | No |
| Yes | Refuge 2 Cross Slope (%) | 2 | No | Gutter 2 Cross Slope (%) | 2.5 |
| N/A | Painted Cross Walk 2 | Yes | No | DWS 2 Provided | No |

**Install Detectable Warning System. Remove & Replace Gutter.**
