# Access Compliance Report Public Rights-of-Way (Island Curb Cuts)

| Main Street: REATA_RD | | Cross Street: REATA_RD | | Location: | NE |
| ADA ID: CCRK211118133842 | Curb Cut Type: MedianRefuge2 | Initial Pass/Fail: Pass | Overall Compliance: No | Severity Score: | 15 |

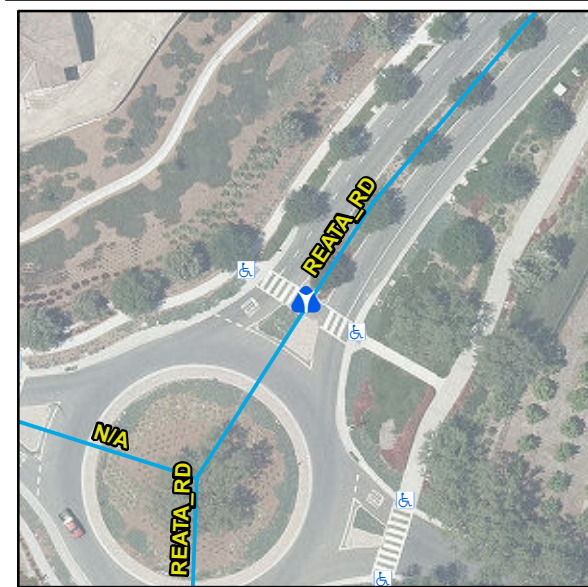
| Compliance | Description | Data | Compliance | Description | Data |
|---|---|---|---|---|---|
| N/A | Painted Cross Walk 1 | Yes | No | DWS 1 Provided | No |
| N/A | Painted Cross Walk 2 | Yes | No | DWS 2 Provided | No |

Install Detectable Warning System.

R305, STD 1115
