Access Compliance Report Public Rights-of-Way (Island Curb Cuts)

Main Street: COW_CAMP_RD **Cross Street:** ANTONIO_PKWY **Location:** S

ADA ID: CCRK211123130146 **Curb Cut Type:** IslandRefuge2 **Initial Pass/Fail:** Fail **Overall Compliance:** No **Severity Score:** 15

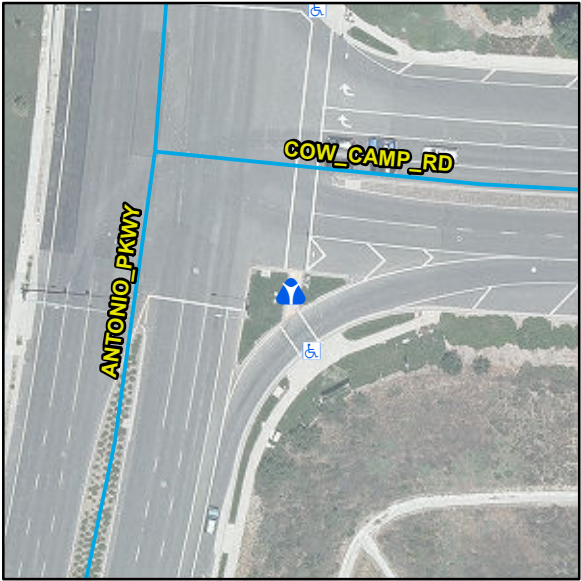
Compliance	Description	Data	Compliance	Description	Data
Yes	Refuge 1 Length (In)	184	N/A	Guttter 1 Ponding	N/A
Yes	Refuge 1 Width (In)	70	Yes	Gutter 1 Lip Ht (In)	0
Yes	Refuge 1 Slope (%)	3.8	N/A	Gutter 1 Slope (%)	N/A
Yes	Refuge 1 Cross Slope (%)	3.9	N/A	Gutter 1 Cross Slope (%)	N/A
N/A	Painted Cross Walk 1	Yes	N/A	DWS 1 Provided	N/A
	Cross Walk 1 Direction	NE	N/A	DWS 1 Contrast	N/A
	Cross Walk 1 Width (In)	144	N/A	DWS 1 Length (In)	N/A
Yes	Refuge Inside Cross Walk 1	Yes	N/A	DWS 1 Full Width	N/A
	Road 1 Slope (%)	4.2	N/A	DWS 1 Offset (In)	N/A
	Road 1 Cross Slope (%)	5.1			N/A
Yes	Refuge 2 Length (In)	120	N/A	Guttter 2 Ponding	N/A
Yes	Refuge 2 Width (In)	70	Yes	Gutter 2 Lip Ht (In)	0
No	Refuge 2 Slope (%)	6.7	N/A	Gutter 2 Slope (%)	N/A
Yes	Refuge 2 Cross Slope (%)	3.8	N/A	Gutter 2 Cross Slope (%)	N/A
N/A	Painted Cross Walk 2	Yes	N/A	DWS 2 Provided	N/A
	Cross Walk 2 Direction	S	N/A	DWS 2 Contrast	N/A
	Cross Walk 2 Width (In)	144	N/A	DWS 2 Length (In)	N/A

Yes	Refuge Inside Cross Walk 2	Yes	N/A	DWS 2 Full Width	N/A
	Road 2 Slope (%)	0.4	N/A	DWS 2 Offset (In)	N/A
	Road 2 Cross Slope (%)	3.6			
Yes	Overall Surface Condition:	Acceptable

Possible Solutions:
Remove & Replace Entire Refuge.

OC Std/PROW:
R302.5, STD 1115

Total Cost: \$ **5000**
