# Access Compliance Report Public Rights-of-Way (Island Curb Cuts)

Main Street: FAUNA\_DR Cross Street: CHIQUITA\_CANYON\_DR Location: NE

ADA ID: CCRK211124123249 Curb Cut Type: MedianRefuge2 Initial Pass/Fail: Pass Overall Compliance: No Severity Score: 0

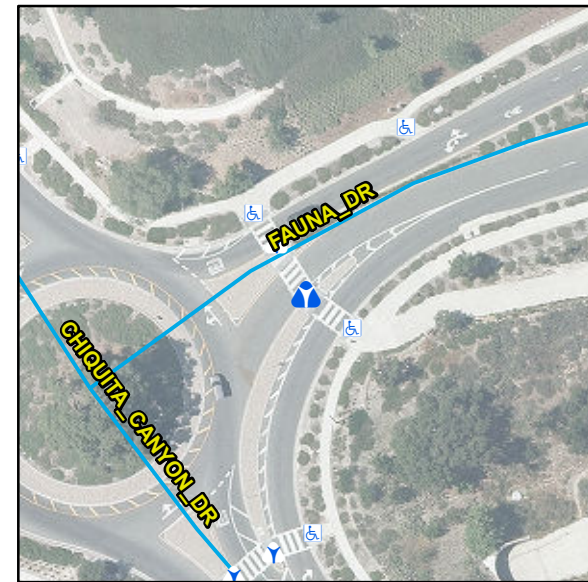
| Compliance | Description | Data | Compliance | Description | Data |
|---|---|---|---|---|---|
| Yes | Refuge 1 Cross Slope (%) | 1.2 | No | Gutter 1 Cross Slope (%) | 3.3 |

Remove & Replace Gutter.

R304.5.3, STD 1115

\$ 252
