# Access Compliance Report Public Rights-of-Way (Island Curb Cuts)

| ADA ID: CCRK211124124623 | Curb Cut Type: MedianRefuge2 | Initial Pass/Fail: Pass | Overall Compliance: No | Severity Score: | 10 |

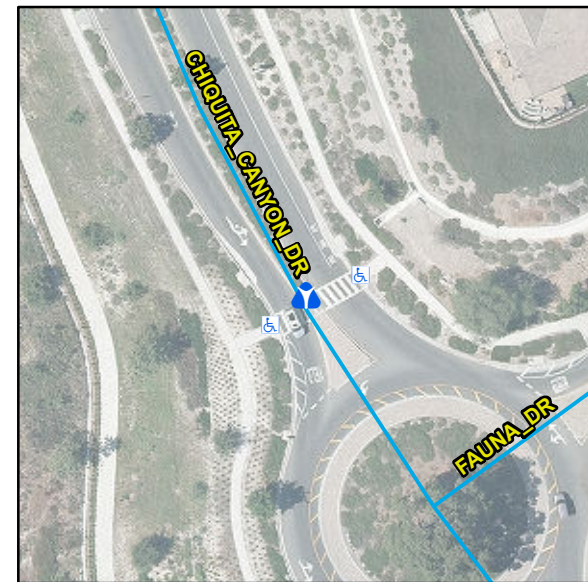
| Compliance | Description | Data | Compliance | Description | Data |
|---|---|---|---|---|---|
| Yes | Refuge 1 Slope (%) | 0.5 | No | Gutter 1 Slope (%) | 7 |

Remove & Replace Gutter.

R304.5.4, STD 1115
