# Access Compliance Report Public Rights-of-Way (Island Curb Cuts)

Main Street: CHIQUITA\_CANYON\_DR Cross Street: CHIQUITA\_CANYON\_DR Location: NE

ADA ID: CCRK211124130933 Curb Cut Type: MedianRefuge2 Initial Pass/Fail: Pass Overall Compliance: No Severity Score: 0

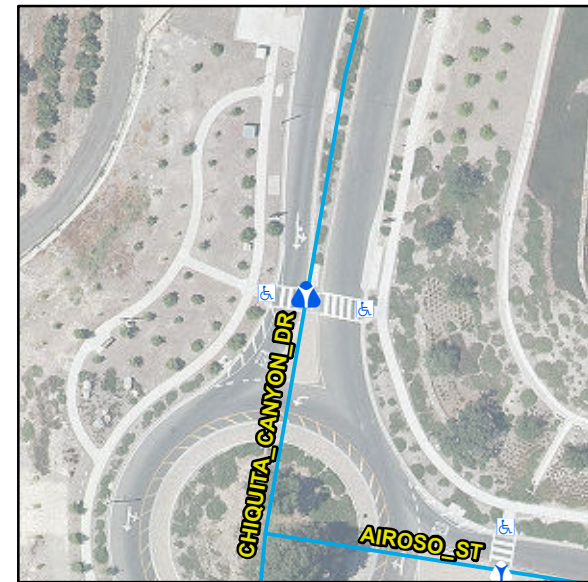
| Compliance | Description | Data | Compliance | Description | Data |
|---|---|---|---|---|---|
| Yes | Refuge 2 Cross Slope (%) | 1.3 | No | Gutter 2 Cross Slope (%) | 3.3 |

Remove & Replace Gutter.

R304.5.3, STD 1115

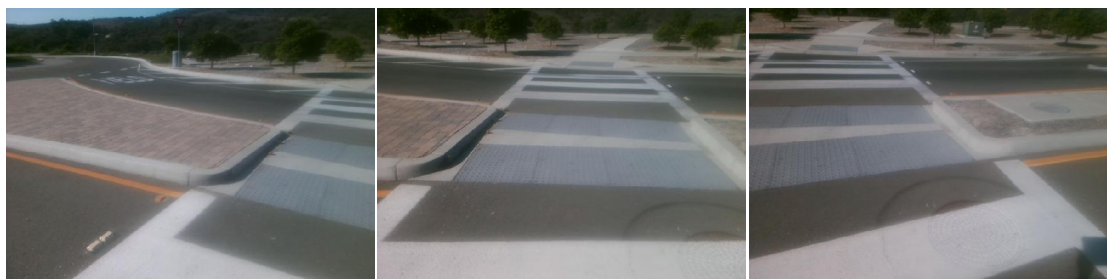
| Compliance | Description | Data | Compliance | Description | Data |
|---|---|---|---|---|---|
| Yes | Overall Surface Condition: | Acceptable | | | |

Possible Solutions:
