# Access Compliance Report Public Rights-of-Way (Island Curb Cuts)

| Main Street: ESENCIA_DR | | Cross Street: ESENCIA_DR | | Location: | S |
| ADA ID: CCRK211129124435 | Curb Cut Type: MedianRefuge2 | Initial Pass/Fail: Pass | Overall Compliance: No | Severity Score: | 10 |

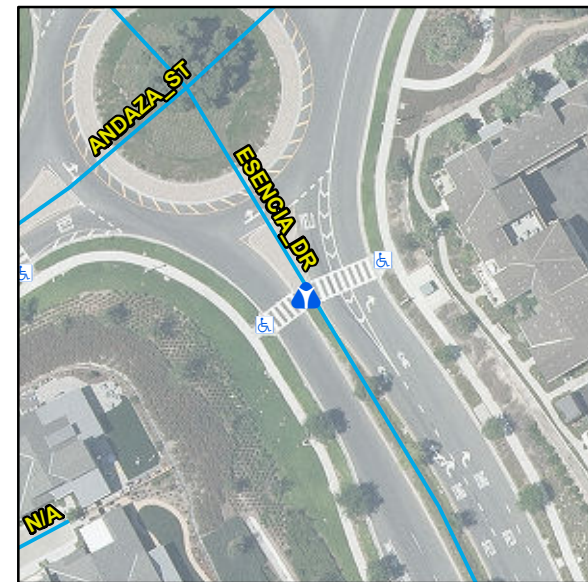
| Compliance | Description | Data | Compliance | Description | Data |
|---|---|---|---|---|---|
| Yes | Refuge 1 Slope (%) | 2.5 | No | Gutter 1 Slope (%) | 6.5 |
| Yes | Refuge 1 Cross Slope (%) | 3.2 | No | Gutter 1 Cross Slope (%) | 3.6 |

Remove & Replace Gutter.

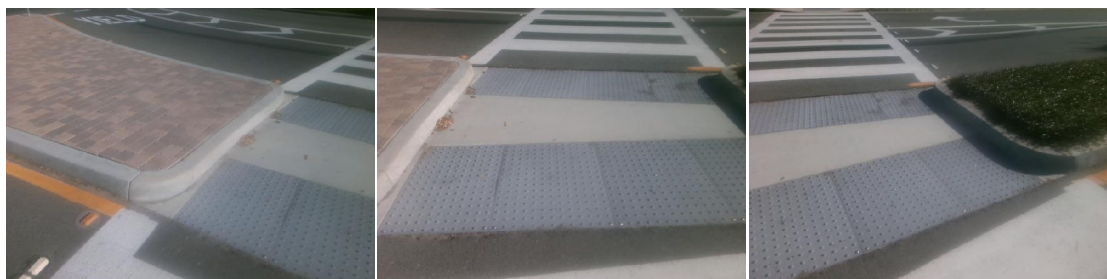
| Compliance | Description | Data | Compliance | Description | Data |
|---|---|---|---|---|---|
| Yes | Refuge 1 Length (In) | 54 | Yes | Guttter 1 Ponding | No |
| Yes | Refuge 1 Width (In) | 96 | Yes | Gutter 1 Lip Ht (In) | 0 |
| Yes | Overall Surface Condition: Acceptable | | | | |

Possible Solutions:
