# Access Compliance Report Public Rights-of-Way (Island Curb Cuts)

| Main Street: ANDAZA_ST | | Cross Street: ANDAZA_ST | | Location: | E |
| ADA ID: CCRK211129132108 | Curb Cut Type: MedianRefuge2 | Initial Pass/Fail: Pass | Overall Compliance: No | Severity Score: | 10 |

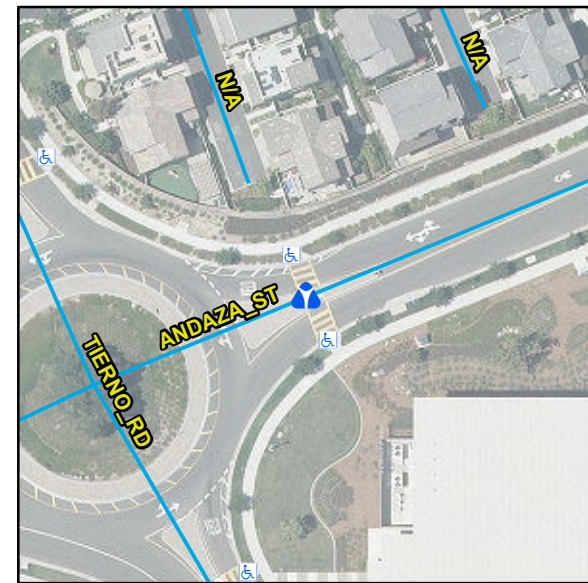
| Compliance | Description | Data | Compliance | Description | Data |
|---|---|---|---|---|---|
| Yes | Refuge 2 Slope (%) | 1.2 | No | Gutter 2 Slope (%) | 7.4 |

Possible Solutions:

Remove & Replace Gutter.

R304.5.4, STD 1115

\$ 252
