# Access Compliance Report Public Rights-of-Way (Island Curb Cuts)

| Main Street: ESENCIA_DR | | Cross Street: ESENCIA_DR | | Location: | N |
| ADA ID: CCRK211201124121 | Curb Cut Type: MedianRefuge2 | Initial Pass/Fail: Fail | Overall Compliance: No | Severity Score: | 15 |

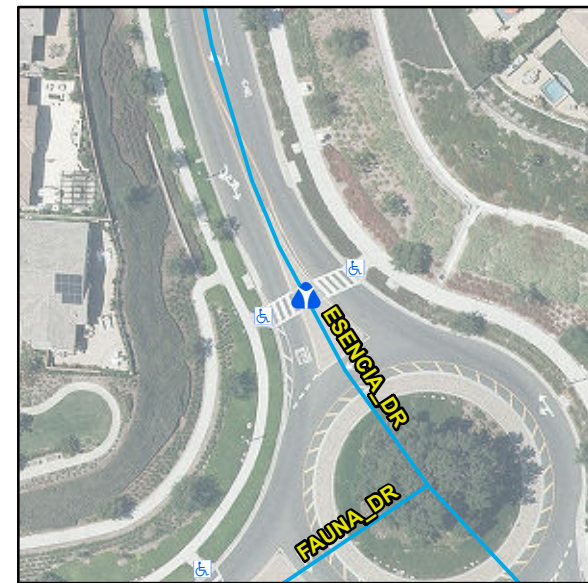
| Compliance | Description | Data | Compliance | Description | Data |
|---|---|---|---|---|---|
| No | Refuge 1 Slope (%) | 5.7 | N/A | Gutter 1 Slope (%) | N/A |
| No | Refuge 2 Slope (%) | 5.9 | N/A | Gutter 2 Slope (%) | N/A |

**Remove & Replace Entire Refuge.**

**R302.5, STD 1115**

**\$ 5000**

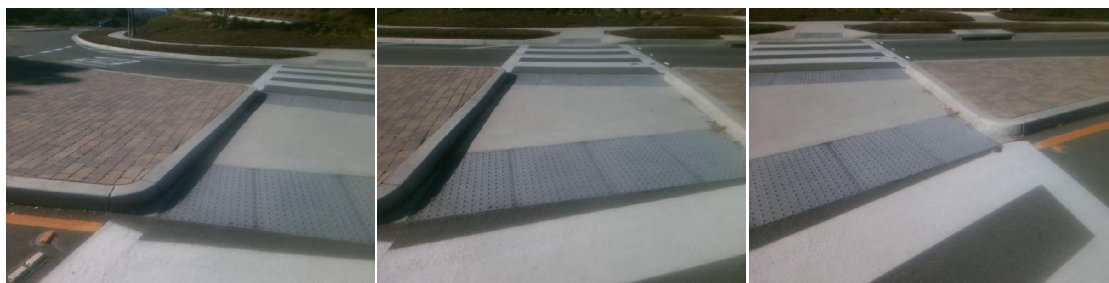
| Compliance | Description | Data | Compliance | Description | Data |
|---|---|---|---|---|---|
| Yes | Overall Surface Condition: <b>Acceptable</b> | | | | |
