# Access Compliance Report Public Rights-of-Way (Island Curb Cuts)

Main Street: ANDAZA\_ST Cross Street: ANDAZA\_ST Location: S

ADA ID: CCRK211202135938 Curb Cut Type: MedianRefuge2 Initial Pass/Fail: Pass Overall Compliance: No Severity Score: 17.5

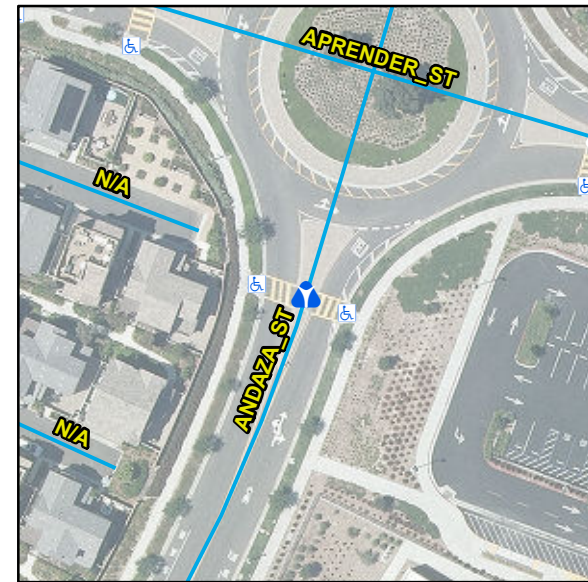
| Compliance | Description | Data | Compliance | Description | Data |
|---|---|---|---|---|---|
| Yes | Refuge 1 Slope (%) | 1 | No | Gutter 1 Slope (%) | 5.1 |
| Yes | Refuge Inside Cross Walk 1 | Yes | No | DWS 1 Full Width | No |
| Yes | Refuge 2 Slope (%) | 0.9 | No | Gutter 2 Slope (%) | 5.1 |

Possible Solutions:  
**Remove & Replace Detectable Warning System.  
Remove & Replace Gutter.**

OC Std/PROW:  
**R305.1.4, R304.5.4, STD 1115**
