# Access Compliance Report Public Rights-of-Way (Island Curb Cuts)

| Main Street: AIROSO_ST | | Cross Street: ANDAZA_ST | | Location: | N |
| ADA ID: CCRK211203113924 | Curb Cut Type: MedianRefuge2 | Initial Pass/Fail: Pass | Overall Compliance: No | Severity Score: | 0 |

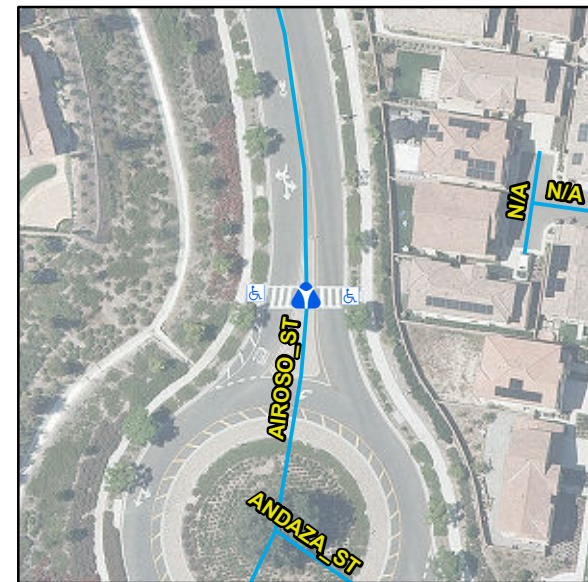
| Compliance | Description | Data | Compliance | Description | Data |
|---|---|---|---|---|---|
| Yes | Refuge 1 Cross Slope (%) | 2.1 | No | Gutter 1 Cross Slope (%) | 2.4 |

Possible Solutions:

Remove & Replace Gutter.

R304.5.3, STD 1115

\$ 252
