# Access Compliance Report Public Rights-of-Way (Island Curb Cuts)

| Main Street: AIROSO_ST | | Cross Street: ANDAZA_ST | | Location: | SW |
| ADA ID: CCRK211203115518 | Curb Cut Type: MedianRefuge2 | Initial Pass/Fail: Pass | Overall Compliance: No | Severity Score: | 15 |

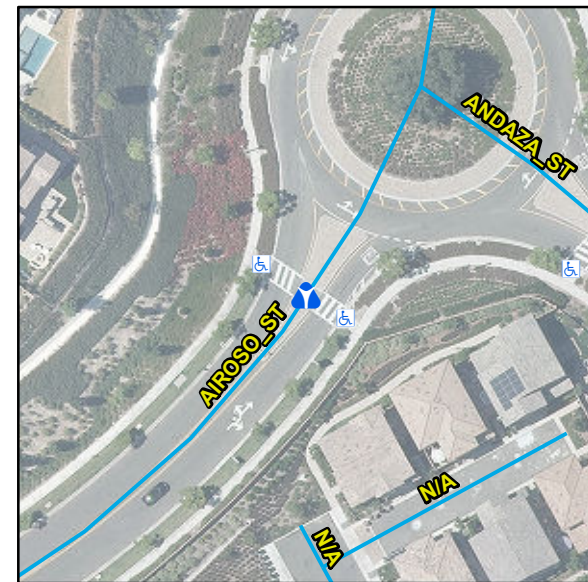
| Compliance | Description | Data | Compliance | Description | Data |
|---|---|---|---|---|---|
| Yes | Refuge 2 Width (In) | 63 | No | Gutter 2 Lip Ht (In) | 1 |

Possible Solutions:

Grind Gutter Lip.

R302.7.2, STD 1115
