# Access Compliance Report Public Rights-of-Way (Island Curb Cuts)

| Main Street: ROSSMOOR_WAY | | Cross Street: ROSSMOOR_WAY | | Location: | W |
| ADA ID: CCRK211217124925 | Curb Cut Type: MedianRefuge2 | Initial Pass/Fail: Fail | Overall Compliance: No | Severity Score: | 6.25 |

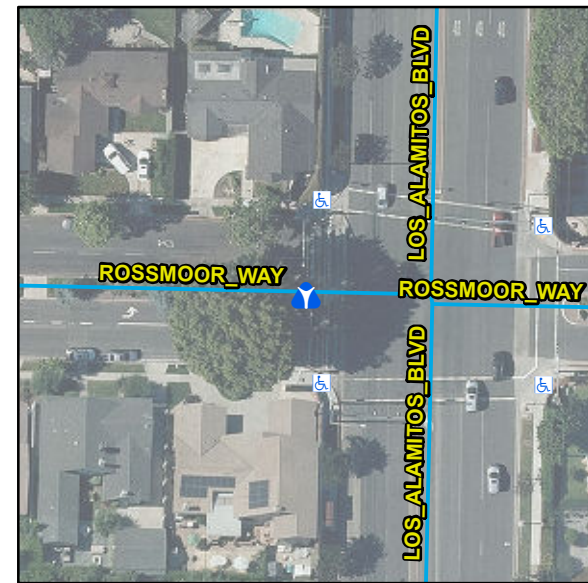
| Compliance | Description | Data | Compliance | Description | Data |
|---|---|---|---|---|---|
| No | Refuge 1 Width (In) | 50 | Yes | Gutter 1 Lip Ht (In) | 0 |
| No | Refuge 2 Width (In) | 50 | Yes | Gutter 2 Lip Ht (In) | 0 |

Possible Solutions:

Remove & Replace Entire Refuge.

R302.3.1, STD 1115

Total Cost: \$ 5000

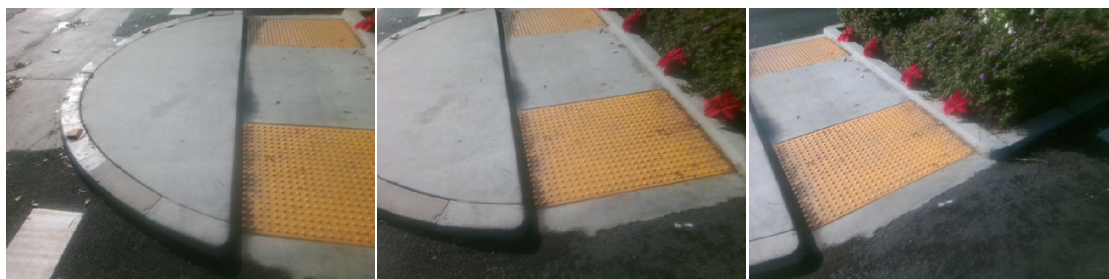
| Compliance | Description | Data | Compliance | Description | Data |
|---|---|---|---|---|---|
| Yes | Overall Surface Condition: Acceptable | | | | |
