# Access Compliance Report Public Rights-of-Way (Island Curb Cuts)

| Main Street: BOLSA_AVE | | Cross Street: PURDY_ST | | Location: | E |
| ADA ID: CCRK220203143550 | Curb Cut Type: MedianRefuge2 | Initial Pass/Fail: Fail | Overall Compliance: No | Severity Score: | 36.25 |

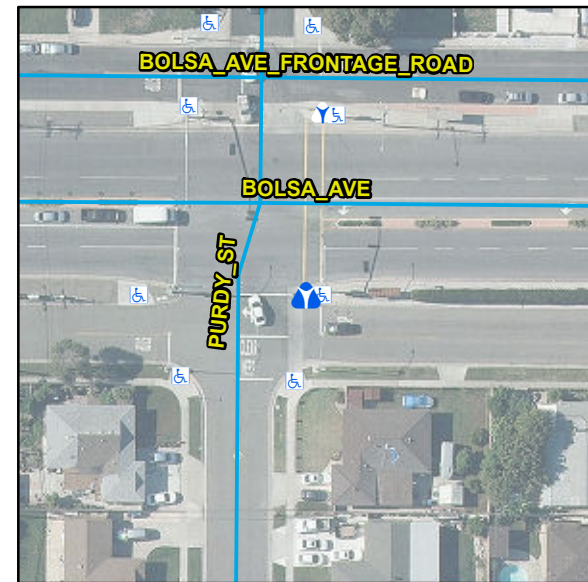
| Compliance | Description | Data | Compliance | Description | Data |
|---|---|---|---|---|---|
| No | Refuge 1 Width (In) | 48 | Yes | Gutter 1 Lip Ht (In) | 0 |
| No | Refuge 1 Slope (%) | 10.2 | N/A | Gutter 1 Slope (%) | N/A |
| No | Refuge 2 Width (In) | 48 | Yes | Gutter 2 Lip Ht (In) | 0 |
| No | Refuge 2 Slope (%) | 9.6 | N/A | Gutter 2 Slope (%) | N/A |

Remove & Replace Entire Refuge.
