# Access Compliance Report Public Rights-of-Way (Curb Ramps)

| Main Street: BANTA_AVE | | Cross Street: GILBERT_ST | | Location: | SE |
| ADA ID: RPAT210916090249 | Ramp Type: Type 4 - Parallel | Initial Pass/Fail: Pass | Overall Compliance: No | Severity Score: | 5 |

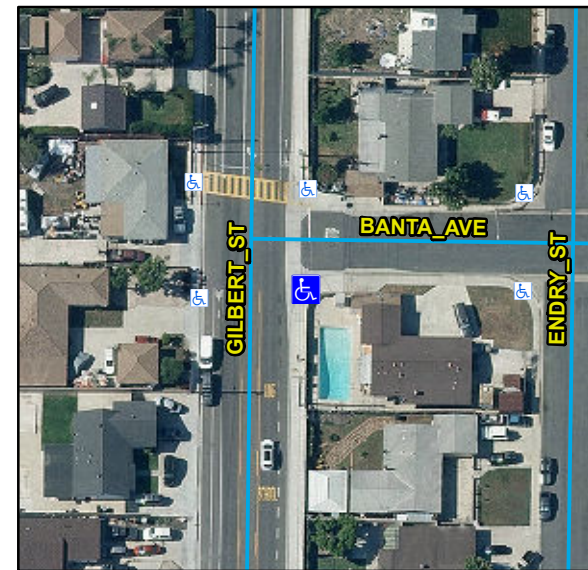
R304.5.4, STD 1115

| Compliance | Description | Data | Compliance | Description | Data |
|---|---|---|---|---|---|
| No | Gutter Run Slope (%) | 7.6 | | Road Cross Slope (%) | 2.6 |

Remove & Replace Gutter.
