# Access Compliance Report Public Rights-of-Way (Curb Ramps)

Main Street: GILBERT\_ST Cross Street: BANTA\_AVE Location: NW

ADA ID: RPAT210916093703 Ramp Type: Type 4 - Parallel Initial Pass/Fail: Pass Overall Compliance: No Severity Score: 5

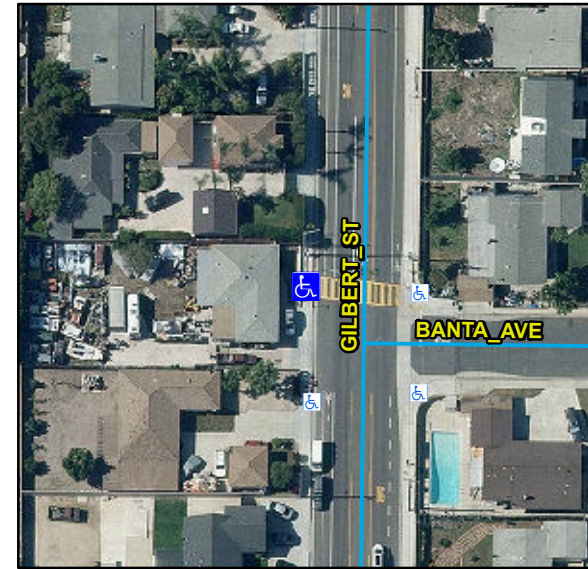
| Compliance | Description | Data | Compliance | Description | Data |
|---|---|---|---|---|---|
| Yes | Gutter Ponding | No | No | Curb Slope | 10.3 |
| No | Gutter Run Slope (%) | 9.2 | | Road Cross Slope (%) | N/A |

Possible Solutions:  
**Remove & Replace Curb Slope. Remove & Replace Gutter. Utility Present.**

OC Std/PROW:  
**R304.2.2, R304.5.4, STD 1115**

Total Cost: \$ 504

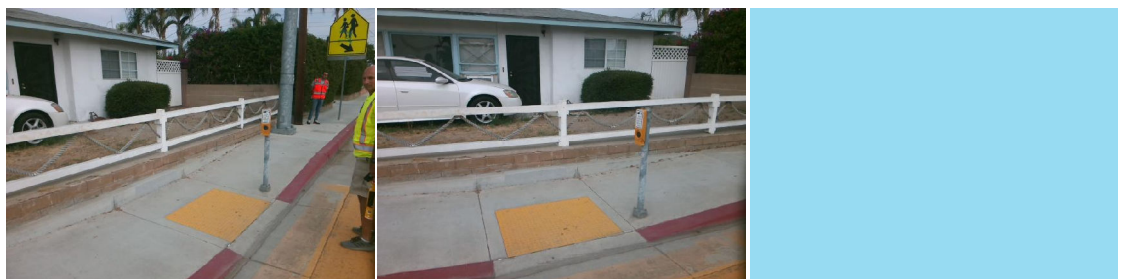
| Compliance | Description | Data | Compliance | Description | Data |
|---|---|---|---|---|---|
| N/A | Ramp Length LT (in) | 96 | N/A | Ramp Length RT (in) | 97 |
| Yes | Ramp Width LT (in) | 65 | Yes | Ramp Width RT (in) | 52 |
| Yes | Ramp Run Slope LT (%) | 7.8 | Yes | Ramp Run Slope RT (%) | 7.9 |
| Yes | Ramp Cross Slope LT (%) | 0.1 | Yes | Ramp Cross Slope RT (%) | 0.5 |
