# Access Compliance Report Public Rights-of-Way (Curb Ramps)

Main Street: KATELLA\_AVE Cross Street: GILBERT\_ST Location: NW

ADA ID: RPAT210916101520 Ramp Type: Type 1 - Perpendicular Diagonal Initial Pass/Fail: Pass Overall Compliance: No Severity Score: 5

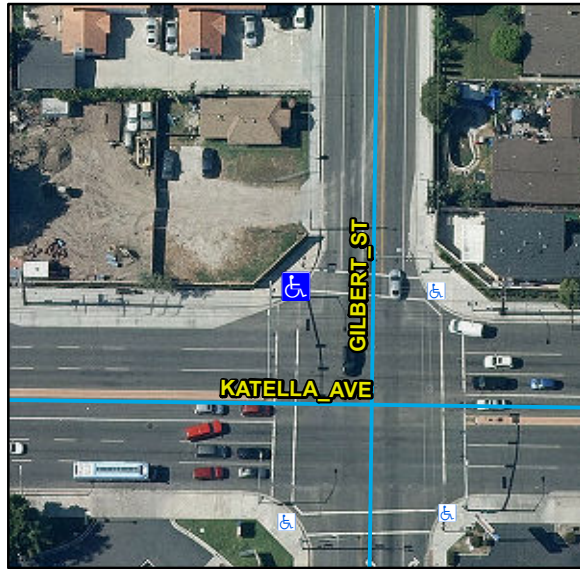
| Compliance | Description | Data | Compliance | Description | Data |
|---|---|---|---|---|---|
| Yes | Gutter Ponding | No | No | Curb Slope | 6.5 |
| No | Gutter Run Slope (%) | 6.5 | | Road Cross Slope (%) | 0.2 |

Remove & Replace Curb Ramp With Two New Directional Ramps or Equivalent. Remove & Replace Gutter.

R304.2.2, R304.2.1, R304.5.4, STD 1115

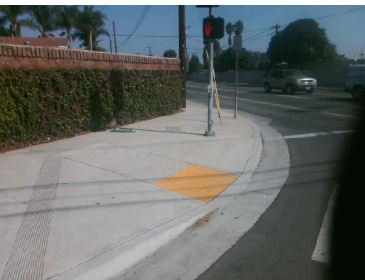
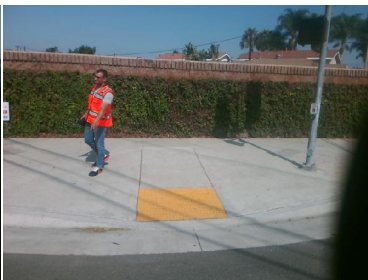
| Compliance | Description | Data | Compliance | Description | Data |
|---|---|---|---|---|---|
| Yes | Overall Surface Condition: Acceptable | | Yes | Perp Joint Present | Yes |
