# Access Compliance Report Public Rights-of-Way (Curb Ramps)

Main Street: GILBERT\_ST Cross Street: KATELLA\_AVE Location: NE

ADA ID: RPAT210916103336 Ramp Type: Type 1 - Perpendicular Diagonal Initial Pass/Fail: Pass Overall Compliance: No Severity Score: 0

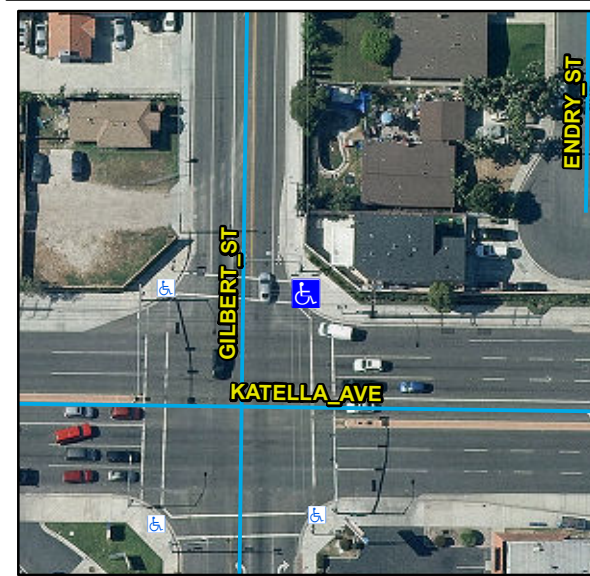
| Compliance | Description | Data | Compliance | Description | Data |
|---|---|---|---|---|---|
| N/A | Landing Movement Obstructed? | Yes | Yes | DWS Contrast | Yes |
| | Landing Movement Type | Bushes | Yes | DWS Length (in) | 36 |

Possible Solutions:  
**Remove & Replace Landing.**

OC Std/PROW:  
**R304.2.1, STD 1115**

Total Cost: \$ 531
