# Access Compliance Report Public Rights-of-Way (Curb Ramps)

Main Street: ENDRY\_ST Cross Street: DECKER\_AVE Location: NE

ADA ID: RPAT210916125957 Ramp Type: Type 1 - Perpendicular Diagonal Initial Pass/Fail: Fail Overall Compliance: No Severity Score: 34

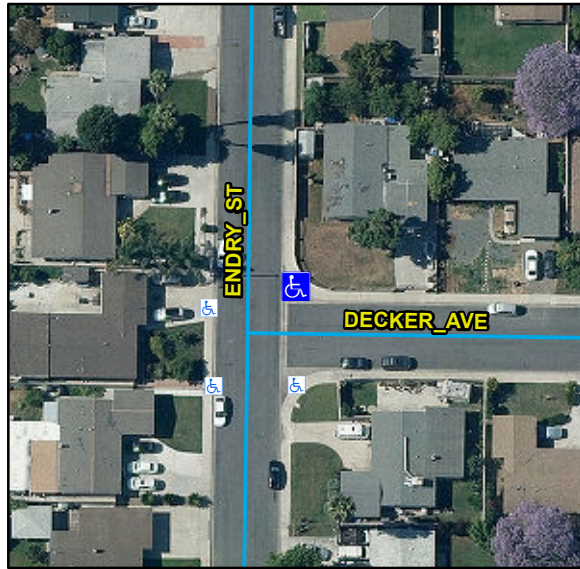
| Compliance | Description | Data | Compliance | Description | Data |
|---|---|---|---|---|---|
| No | Ramp Width (in) | 39 | | | N/A |
| No | Ramp Run Slope (%) | 14.3 | N/A | Flare Slope LT (%) | N/A |

Remove & Replace Curb Ramp With Two New Directional Ramps or Equivalent.

R304.5.1, R304.2.2, STD 1115
