# Access Compliance Report Public Rights-of-Way (Curb Ramps)

| Main Street: DECKER_AVE | | Cross Street: ENDRY_ST | | Location: | SE |
| ADA ID: RPAT210916130557 | Ramp Type:Type 1 - Perpendicular Diagonal Initial Pass/Fail: Fail | | Overall Compliance: No | Severity Score: | 20 |

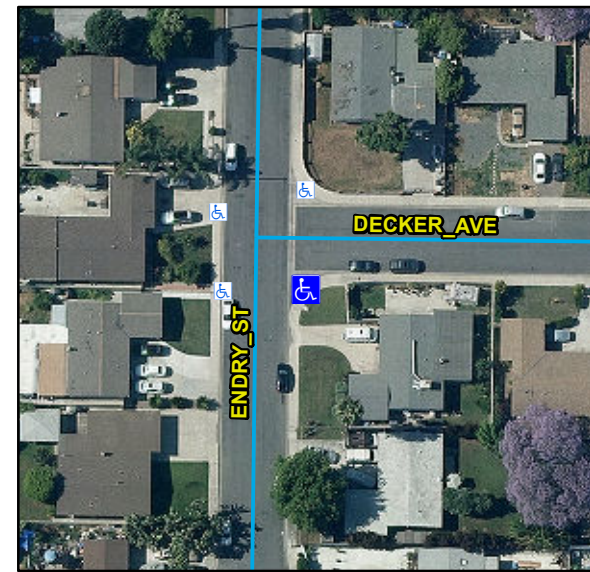
| Compliance | Description | Data | Compliance | Description | Data |
|---|---|---|---|---|---|
| No | Ramp Width (in) | 41 | | | N/A |
| No | Ramp Run Slope (%) | 9.4 | N/A | Flare Slope LT (%) | N/A |

**Remove & Replace Curb Ramp With Two New Directional Ramps or Equivalent.**

**R304.2.2, R304.5.1, STD 1115**
