# Access Compliance Report Public Rights-of-Way (Curb Ramps)

Main Street: FRALEY\_ST Cross Street: DECKER\_AVE Location: SW

ADA ID: RPAT210916131259 Ramp Type: Type 4 - Parallel Initial Pass/Fail: Pass Overall Compliance: Yes Severity Score: 0

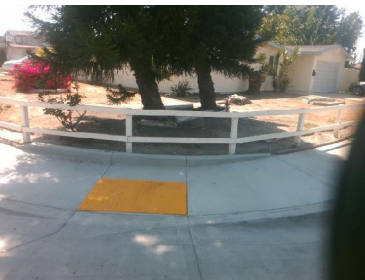
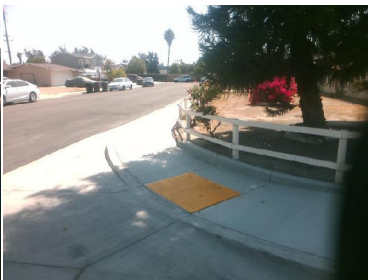
| Compliance | Description | Data | Compliance | Description | Data |
|---|---|---|---|---|---|
| Yes | Overall Surface Condition | Acceptable | | | |
