# Access Compliance Report Public Rights-of-Way (Curb Ramps)

Main Street: **DECKER\_AVE** Cross Street: **JEAN\_ST** Location: **NW**

ADA ID: **RPAT210916134730** Ramp Type: **Type 4 - Parallel** Initial Pass/Fail: **Fail** Overall Compliance: **No** Severity Score: **2**

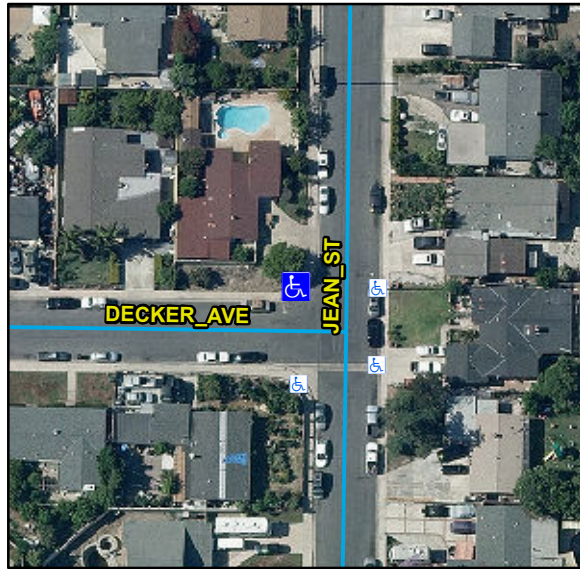
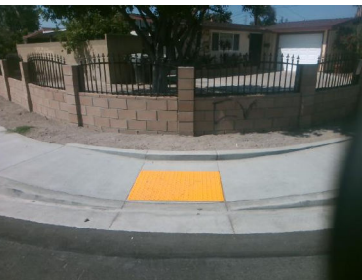
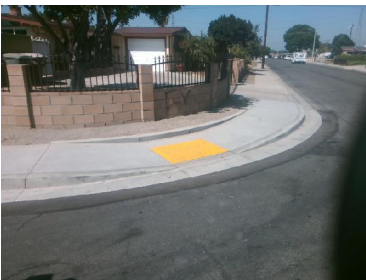
| Compliance | Description | Data | Compliance | Description | Data |
|---|---|---|---|---|---|
| <b>No</b> | Ramp Cross Slope LT (%) | <b>3</b> | <b>Yes</b> | Ramp Cross Slope RT (%) | <b>1.2</b> |

**Remove & Replace Curb Ramp With Two New Directional Ramps or Equivalent.**

**R304.5.3, STD 1115**
