# Access Compliance Report Public Rights-of-Way (Curb Ramps)

Main Street: KATELLA\_AVE Cross Street: JEAN\_ST Location: NW

ADA ID: RPAT210916135409 Ramp Type: Type 1 - Perpendicular Diagonal Initial Pass/Fail: Fail Overall Compliance: No Severity Score: 15

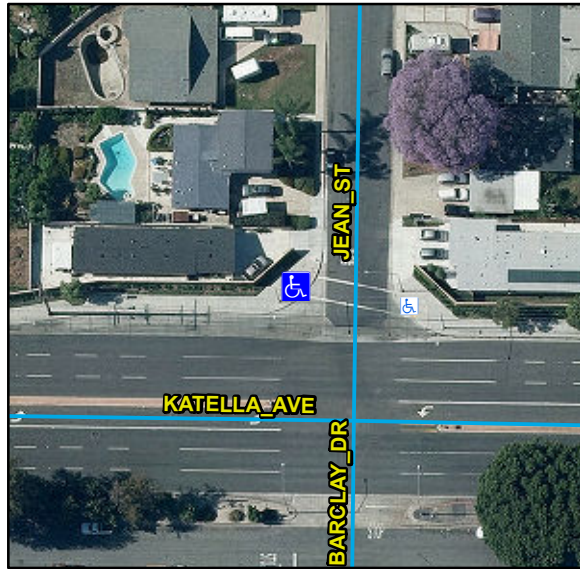
| Compliance | Description | Data | Compliance | Description | Data |
|---|---|---|---|---|---|
| No | Ramp Run Slope (%) | 8.5 | N/A | Flare Slope LT (%) | N/A |
| N/A | Gutter Ponding | N/A | No | Curb Slope | 7.1 |

Remove & Replace Curb Ramp With Two New Directional Ramps or Equivalent. Restripe Crosswalk.

R304.2.2, STD 1115
