# Access Compliance Report Public Rights-of-Way (Curb Ramps)

| Main Street: BARCLAY_DR | | Cross Street: KATELLA_AVE | | Location: | SW |
| ADA ID: RPAT210916140051 | Ramp Type: Type 4 - Parallel | Initial Pass/Fail: Fail | Overall Compliance: No | Severity Score: | 30 |

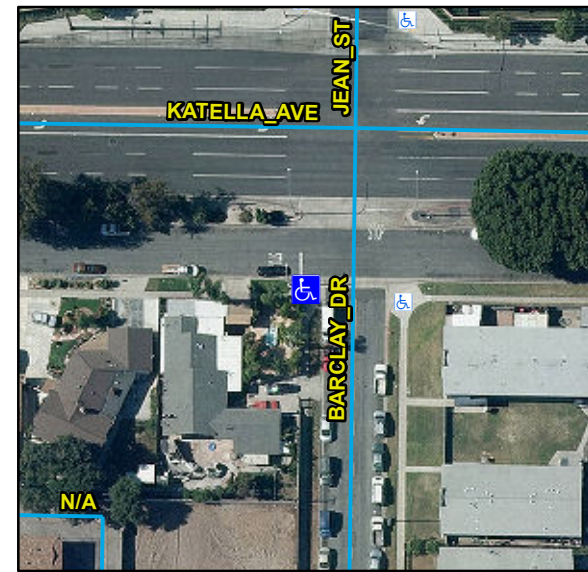
| Compliance | Description | Data | Compliance | Description | Data |
|---|---|---|---|---|---|
| No | Ramp Run Slope LT (%) | 8.5 | Yes | Ramp Run Slope RT (%) | 6.8 |
| No | Ramp Cross Slope LT (%) | 5.6 | Yes | Ramp Cross Slope RT (%) | 0.1 |

**Remove & Replace Curb Ramp With Two New Directional Ramps or Equivalent.**

**R204.3, R304.3.2, R304.5.3, STD 1115**

Total Cost: \$ 4000

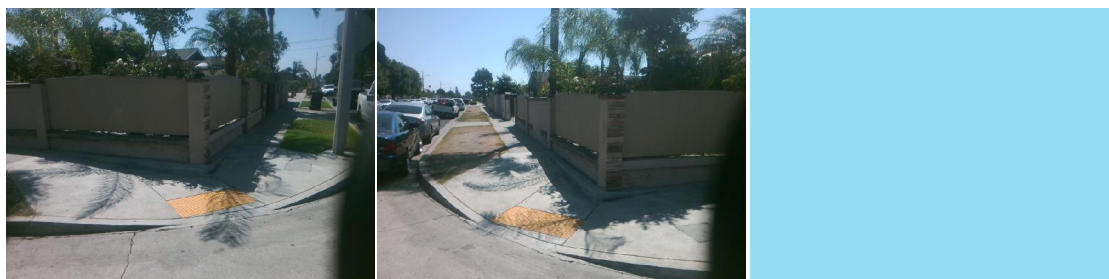
| Compliance | Description | Data | Compliance | Description | Data |
|---|---|---|---|---|---|
| N/A | Ramp Length LT (in) | 77 | N/A | Ramp Length RT (in) | 98 |
| Yes | Ramp Width LT (in) | 48 | Yes | Ramp Width RT (in) | 67 |
