# Access Compliance Report

## Public Rights-of-Way

### (Curb Ramps)

Main Street: MAUREEN\_DR Cross Street: BARCLAY\_DR Location: NW

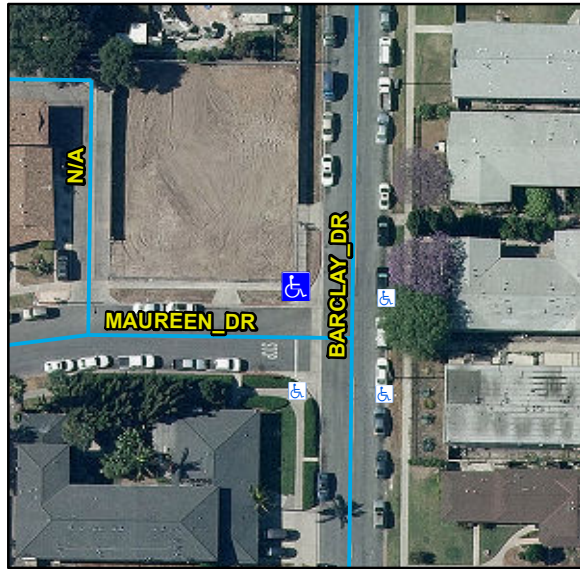
ADA ID: RPAT210916141458 Ramp Type: Type 3 - Combination 1 Initial Pass/Fail: Pass Overall Compliance: No Severity Score: 0

| Compliance | Description | Data | Compliance | Description | Data |
|---|---|---|---|---|---|
| Yes | Gutter Ponding | No | No | Curb Slope | 7.9 |

Possible Solutions:

Remove & Replace Curb Slope.

R304.2.2, STD 1115
