Access Compliance Report Public Rights-of-Way (Curb Ramps)

Main Street: BARCLAY_DR **Cross Street:** MAUREEN_DR **Location:** SW

ADA ID: RPAT210916142419 **Ramp Type:** Type 3 - Combination 1 **Initial Pass/Fail:** Pass **Overall Compliance:** No **Severity Score:** 0

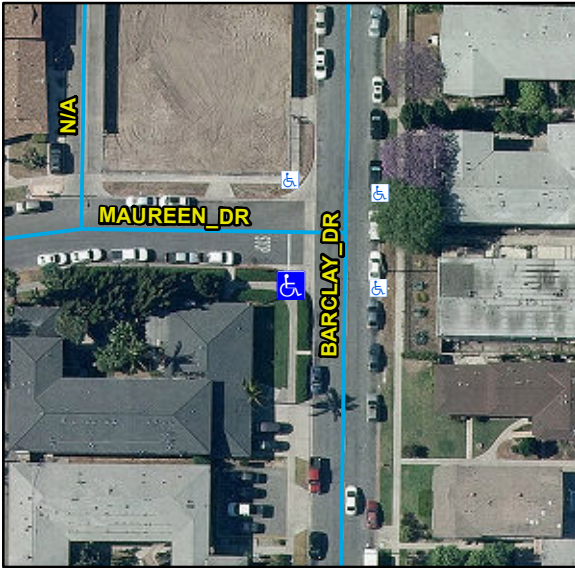
Compliance	Description	Data	Compliance	Description	Data
N/A	Ramp Length LT (in)	52	N/A	Ramp Length RT (in)	40
Yes	Ramp Width LT (in)	50	Yes	Ramp Width RT (in)	53
Yes	Ramp Run Slope LT (%)	5.6	Yes	Ramp Run Slope RT (%)	5.1
Yes	Ramp Cross Slope LT (%)	0.6	Yes	Ramp Cross Slope RT (%)	0.6
N/A	Ramp Length (in)	69	N/A	Flare Type LT	
Yes	Ramp Width (in)	48			Sloped
Yes	Ramp Run Slope (%)	7.2	N/A	Flare Slope LT (%)	6.5
Yes	Ramp Cross Slope (%)	1.9	N/A	Flare Traversable LT	No
N/A	Landing Present	Yes	N/A	Flare Type RT	
Yes	Landing Length (in)	53			Sloped
Yes	Landing Width (in)	61	N/A	Flare Slope RT (%)	9.4
Yes	Landing Run Slope (%)	1	N/A	Flare Traversable RT	No
No	Landing Cross Slope (%)	4	Yes	DWS Provided	Yes
N/A	Landing Movement Obstructed?	No	Yes	DWS Contrast	Yes
	Landing Movement Type	N/A	Yes	DWS Length (in)	36
N/A	Landing Shared	No	Yes	DWS Full Width	Yes
N/A	Clear Space	Yes		DWS Offset Type	Single
N/A	Clear Space To Crosswalk (in)	48	Yes	DWS Offset Left (in)	0

Yes	DWS Offset Right (in)	N/A
Yes	Perp Joint Present	Yes			
	Parallel Ramp Side	N/A			
N/A	Marked Crosswalk 1	No	N/A	Marked Crosswalk 2	No
	Crossing 1 Direction	E		Crossing 2 Direction	N
	Marked Crosswalk 1 Width (in)	N/A		Marked Crosswalk 2 Width (in)	N/A
N/A	Ramp Inside Crosswalk 1	N/A	Yes	Ramp Inside Crosswalk 2	N/A
	Crossing 1 Slope (%)	4		Crossing 2 Slope (%)	0.3
	Crossing 1 Cross Slope (%)	0.9		Crossing 2 Cross Slope (%)	1
Yes	Gutter Ponding	No	No	Curb Slope	9
Yes	Gutter Lip Height (in)	0		Road Run Slope (%)	1.5
Yes	Gutter Run Slope (%)	1.8		Road Cross Slope (%)	0.2
No	Gutter Cross Slope (%)	2.5			
Yes	Overall Surface Condition:	Acceptable			
	Cross Gutter Present?	Yes		Spandrel Present?	Yes
	Replace Cross Gutter?	No		Replace Spandrel?	No

Possible Solutions:
Remove & Replace Curb Ramp With Two New Directional Ramps or Equivalent. Remove & Replace Gutter.

OC Std/PROW:
R304.2.2, R304.5.3, STD 1115

Total Cost: \$ 6412
