# Access Compliance Report Public Rights-of-Way (Curb Ramps)

Main Street: BANTA\_AVE Cross Street: JEAN\_ST Location: NW

ADA ID: RPAT210916150225 Ramp Type: Type 1 - Perpendicular Diagonal Initial Pass/Fail: Fail Overall Compliance: No Severity Score: 34

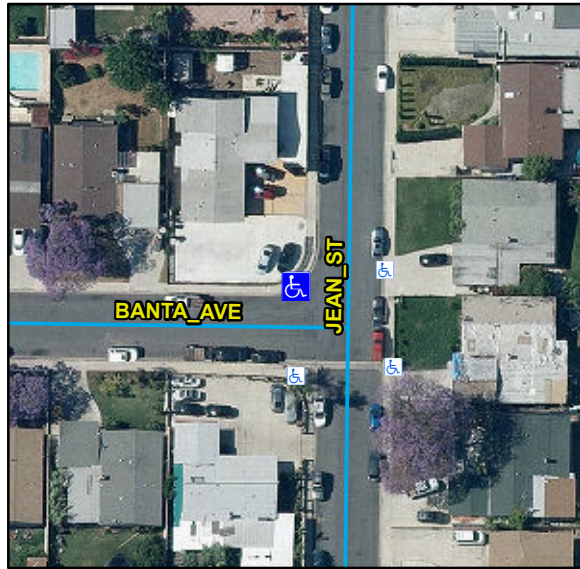
| Compliance | Description | Data | Compliance | Description | Data |
|---|---|---|---|---|---|
| N/A | Ramp Length (in) | 57 | N/A | Flare Type LT | |
| No | Ramp Width (in) | 39 | | | N/A |
| No | Ramp Run Slope (%) | 12.8 | N/A | Flare Slope LT (%) | N/A |
| Yes | Ramp Cross Slope (%) | 1.1 | N/A | Flare Traversable LT | N/A |
| No | Gutter Lip Height (in) | 1 | | Road Run Slope (%) | 2.1 |

Remove & Replace Curb Ramp With Two New Directional Ramps or Equivalent.

R304.2.2, R304.5.1, R302.7.2, STD 1115

Total Cost: \$ 6160
