# Access Compliance Report Public Rights-of-Way (Curb Ramps)

Main Street: JEAN\_ST Cross Street: CRESTWOOD\_LN Location: SW

ADA ID: RPAT210916150820 Ramp Type: Type 4 - Parallel Initial Pass/Fail: Pass Overall Compliance: No Severity Score: 5

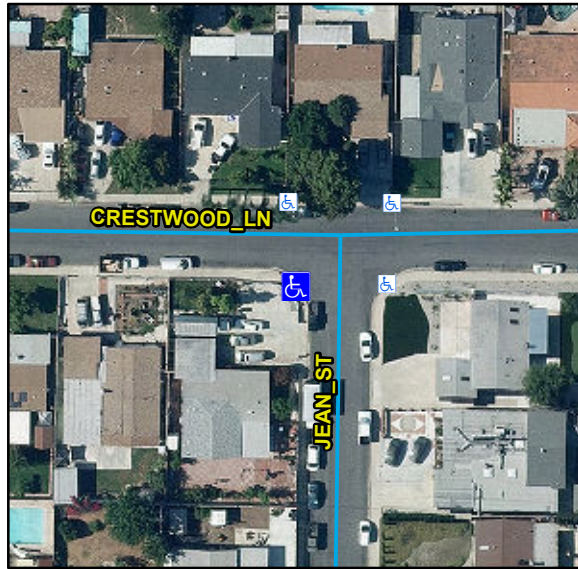
| Compliance | Description | Data | Compliance | Description | Data |
|---|---|---|---|---|---|
| No | Gutter Run Slope (%) | 9.3 | | Road Cross Slope (%) | 4.3 |

Possible Solutions:

Remove & Replace Gutter.

R304.5.4, STD 1115

Total Cost: \$ 252
