# Access Compliance Report Public Rights-of-Way (Curb Ramps)

Main Street: ROCKAWAY\_DR Cross Street: HAMER\_LN Location: NW

ADA ID: RPAT210917092545 Ramp Type: Type 1 - Perpendicular Diagonal Initial Pass/Fail: Pass Overall Compliance: No Severity Score: 2

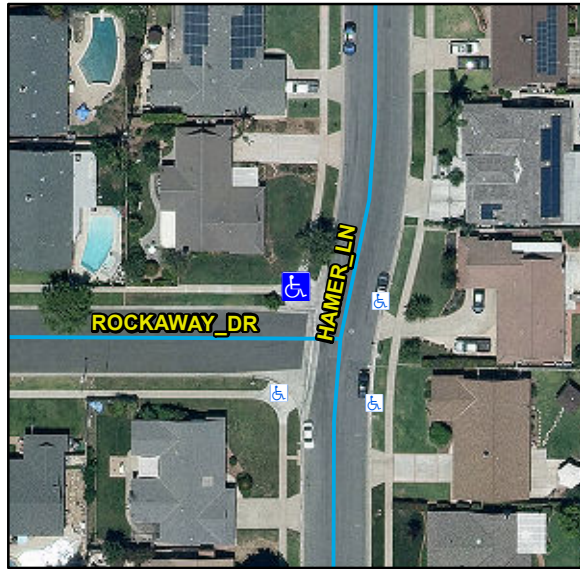
| Compliance | Description | Data | Compliance | Description | Data |
|---|---|---|---|---|---|
| Yes | Gutter Ponding | No | No | Curb Slope | 11 |

Remove & Replace Curb Slope.

R304.2.2, STD 1115
