# Access Compliance Report Public Rights-of-Way (Curb Ramps)

Main Street: KENOAK\_DR Cross Street: CEDARLAWN\_DR Location: NW

ADA ID: RPAT210917095839 Ramp Type: Type 1 - Perpendicular Diagonal Initial Pass/Fail: Pass Overall Compliance: No Severity Score: 2

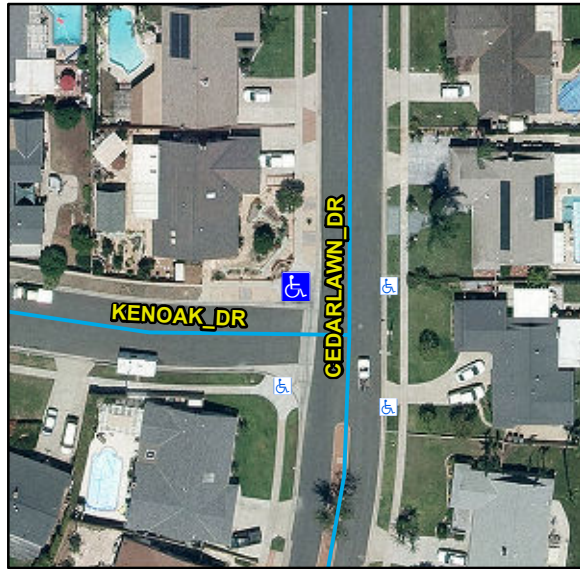
| Compliance | Description | Data | Compliance | Description | Data |
|---|---|---|---|---|---|
| Yes | Gutter Ponding | No | No | Curb Slope | 14.9 |

Remove & Replace Curb Ramp With Two New Directional Ramps or Equivalent.

R304.2.2, R304.2.1, STD 1115
