# Access Compliance Report Public Rights-of-Way (Curb Ramps)

Main Street: CEDARLAWN\_DR Cross Street: KENOAK\_DR Location: W

ADA ID: RPAT210917101346 Ramp Type: Type 1 - Perpendicular Diagonal Initial Pass/Fail: Fail Overall Compliance: No Severity Score: 2

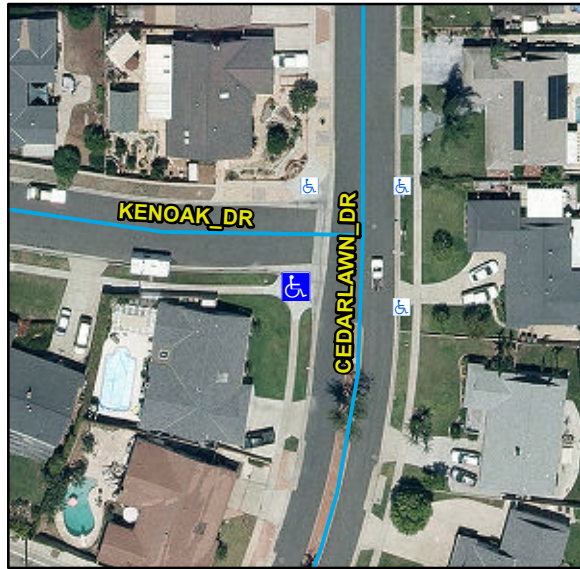
| Compliance | Description | Data | Compliance | Description | Data |
|---|---|---|---|---|---|
| No | Ramp Cross Slope (%) | 2.1 | N/A | Flare Traversable LT | N/A |
| N/A | Gutter Ponding | N/A | No | Curb Slope | 11.8 |

Remove & Replace Curb Ramp With Two New Directional Ramps or Equivalent.

R304.2.2, R304.5.3, STD 1115
