# Access Compliance Report Public Rights-of-Way (Curb Ramps)

Main Street: CEDARLAWN\_DR Cross Street: PALM\_DR Location: NE

ADA ID: RPAT210917103144 Ramp Type: Type 1 - Perpendicular Diagonal Initial Pass/Fail: Pass Overall Compliance: No Severity Score: 29

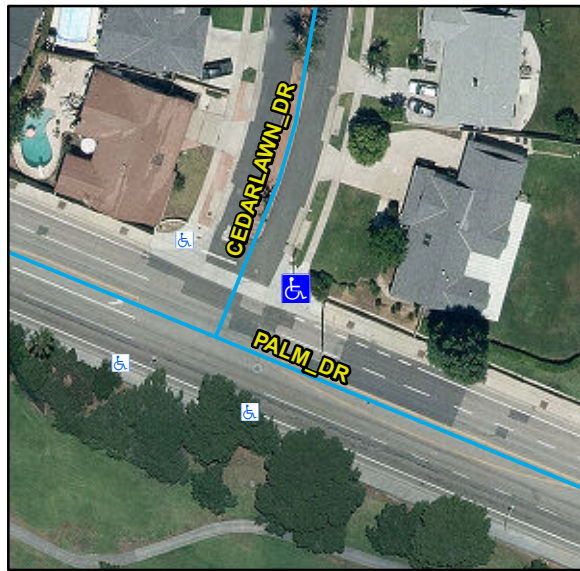
| Compliance | Description | Data | Compliance | Description | Data |
|---|---|---|---|---|---|
| Yes | Ramp Run Slope (%) | 7.1 | No | Flare Slope LT (%) | 12.3 |
| No | Ramp Cross Slope (%) | 5.5 | N/A | Flare Traversable LT | Yes |
| No | Landing Cross Slope (%) | 7.4 | Yes | DWS Provided | Yes |
| Yes | Gutter Ponding | No | No | Curb Slope | 8.7 |
| No | Gutter Cross Slope (%) | 6.5 | | | |

Remove & Replace Curb Ramp With Two New Directional Ramps or Equivalent. Remove & Replace Gutter.

R304.2.2, R304.5.3, R304.2.1, R304.2.3, STD 1115
