# Access Compliance Report Public Rights-of-Way (Curb Ramps)

Main Street: PALM\_DR Cross Street: WARREN\_ST Location: NW

ADA ID: RPAT210917104039 Ramp Type: Type 1 - Perpendicular Diagonal Initial Pass/Fail: Pass Overall Compliance: No Severity Score: 0

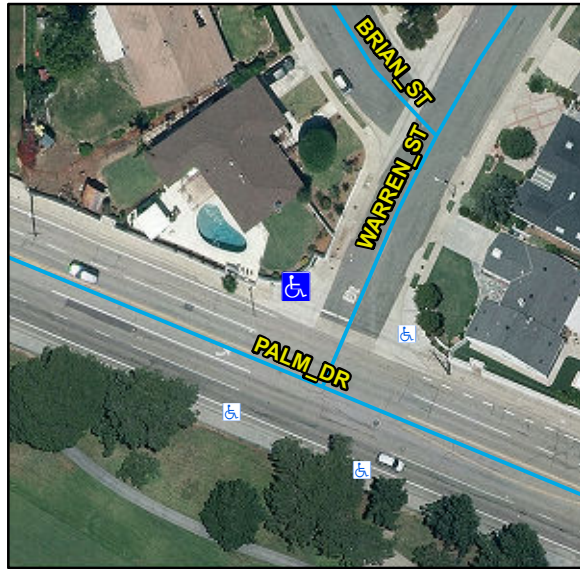
| Compliance | Description | Data | Compliance | Description | Data |
|---|---|---|---|---|---|
| Yes | Gutter Ponding | No | No | Curb Slope | 13 |

Remove & Replace Curb Ramp With Two New Directional Ramps or Equivalent.

R304.2.2, R304.2.1, STD 1115
