# Access Compliance Report Public Rights-of-Way (Curb Ramps)

Main Street: ARROWHEAD\_DR Cross Street: E ROCKAWAY\_DR Location: SW

ADA ID: RPAT210917110830 Ramp Type: Type 3 - Combination 1 Initial Pass/Fail: Fail Overall Compliance: No Severity Score: 5

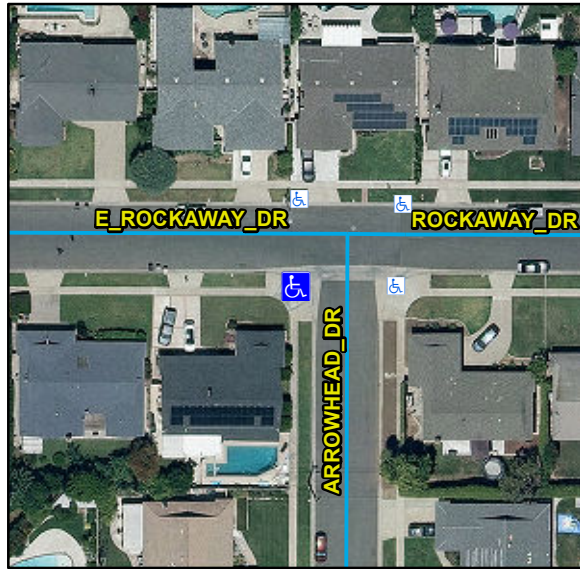
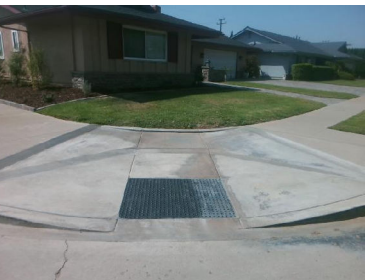
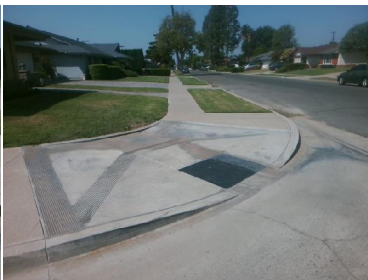
| Compliance | Description | Data | Compliance | Description | Data |
|---|---|---|---|---|---|
| Yes | Ramp Width LT (in) | 48 | No | Ramp Width RT (in) | 46 |

**Remove & Replace Curb Ramp With Two New Directional Ramps or Equivalent. Remove & Replace Sidewalk.**
