# Access Compliance Report Public Rights-of-Way (Curb Ramps)

Main Street: ROCKAWAY\_DR Cross Street: ARROWHEAD\_DR Location: SE

ADA ID: RPAT210917111434 Ramp Type: Type 1 - Perpendicular Diagonal Initial Pass/Fail: Pass Overall Compliance: No Severity Score: 6

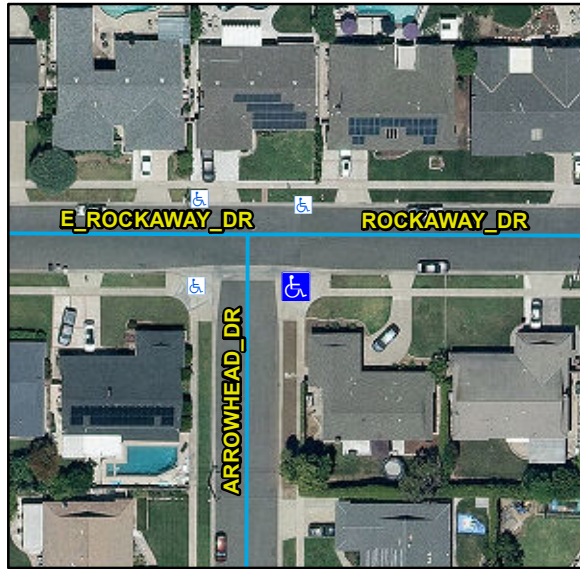
| Compliance | Description | Data | Compliance | Description | Data |
|---|---|---|---|---|---|
| Yes | Gutter Ponding | No | No | Curb Slope | 7.6 |

Remove & Replace Curb Ramp With Two New Directional Ramps or Equivalent.

R304.2.2, R304.2.1, STD 1115

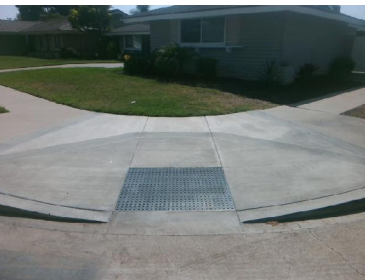
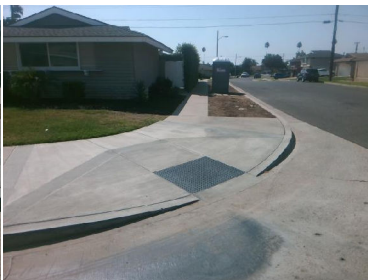
| Compliance | Description | Data | Compliance | Description | Data |
|---|---|---|---|---|---|
| Yes | Overall Surface Condition: Acceptable | | Yes | Perp Joint Present | Yes |
