# Access Compliance Report Public Rights-of-Way (Curb Ramps)

Main Street: **HAMER\_DR** Cross Street: **SHADBURN\_AVE** Location: **NE**

ADA ID: **RPAT210917124220** Ramp Type: **Type 1 - Perpendicular Diagonal** Initial Pass/Fail: **Pass** Overall Compliance: **No** Severity Score: **4**

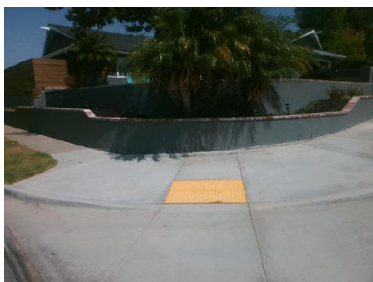
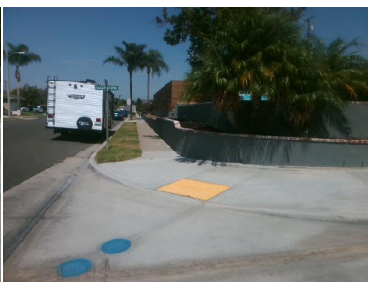
| Compliance | Description | Data | Compliance | Description | Data |
|---|---|---|---|---|---|
| N/A | Landing Movement Obstructed? | Yes | Yes | DWS Contrast | Yes |
| | Landing Movement Type | Curb | Yes | DWS Length (in) | 36 |
| Yes | Gutter Ponding | No | No | Curb Slope | 7.6 |

**Remove & Replace Curb Ramp With Two New Directional Ramps or Equivalent.**

**R304.2.2, R304.2.1, STD 1115**
