# Access Compliance Report Public Rights-of-Way (Curb Ramps)

Main Street: SHADBURN\_AVE Cross Street: HAMER\_DR Location: SE

ADA ID: RPAT210917125001 Ramp Type: Type 1 - Perpendicular Diagonal Initial Pass/Fail: Pass Overall Compliance: No Severity Score: 9

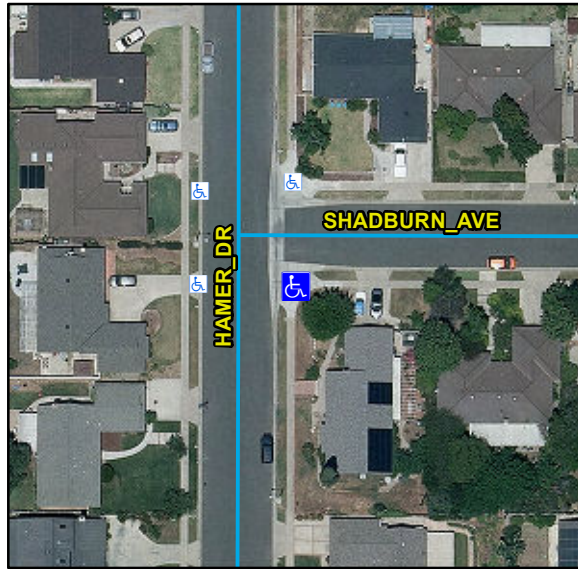
| Compliance | Description | Data | Compliance | Description | Data |
|---|---|---|---|---|---|
| Yes | Gutter Ponding | No | No | Curb Slope | 13.6 |
| No | Gutter Run Slope (%) | 5.6 | | Road Cross Slope (%) | 0.4 |

Remove & Replace Curb Ramp With Two New Directional Ramps or Equivalent. Remove & Replace Gutter.
