# Access Compliance Report Public Rights-of-Way (Curb Ramps)

Main Street: CARTLEN\_DR Cross Street: TABAH\_LN Location: NE

ADA ID: RPAT210917130056 Ramp Type: Type 1 - Perpendicular Diagonal Initial Pass/Fail: Fail Overall Compliance: No Severity Score: 15

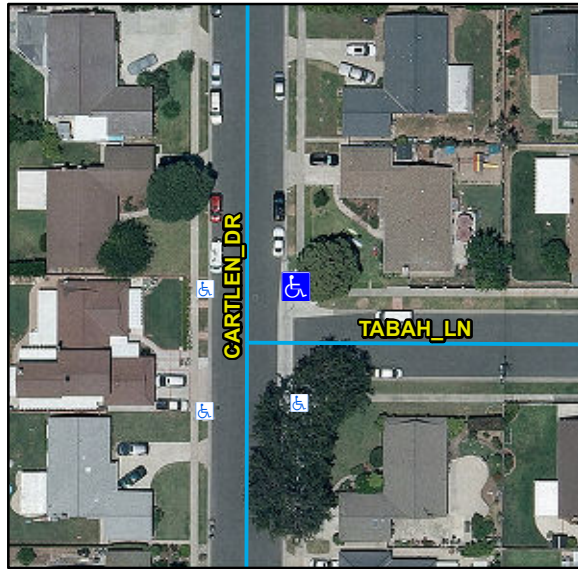
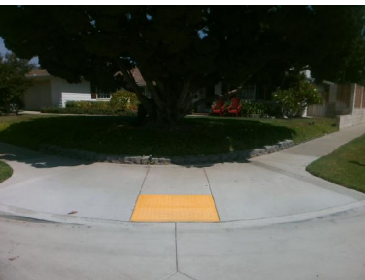
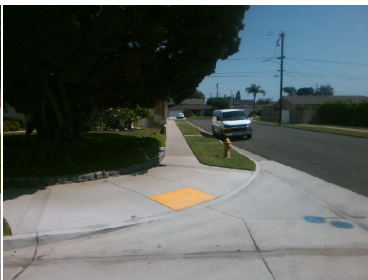
| Compliance | Description | Data | Compliance | Description | Data |
|---|---|---|---|---|---|
| No | Ramp Run Slope (%) | 8.6 | N/A | Flare Slope LT (%) | N/A |

Remove & Replace Curb Ramp With Two New Directional Ramps or Equivalent.

R304.2.2, STD 1115
