# Access Compliance Report Public Rights-of-Way (Curb Ramps)

Main Street: **CARTHAGE\_ST** Cross Street: **TUNISIA\_CIR** Location: **SW**

ADA ID: **RPAT210917134521** Ramp Type: **Type 1 - Perpendicular Diagonal Initial Pass/Fail: Fail** Overall Compliance: **No** Severity Score: **2**

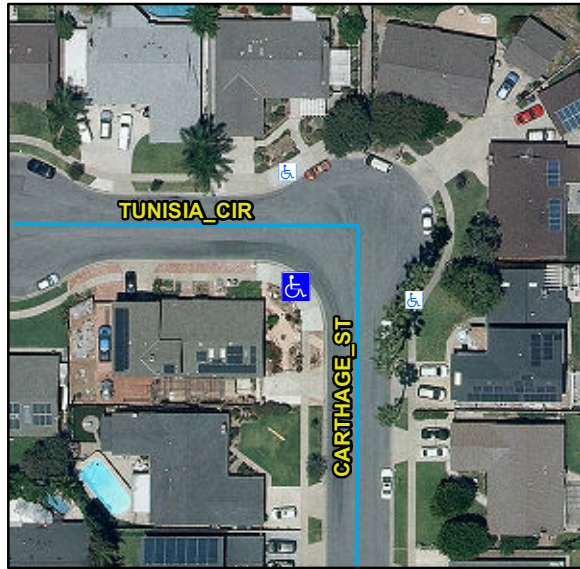
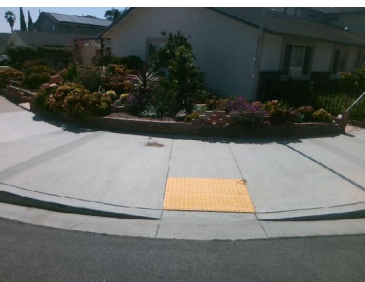
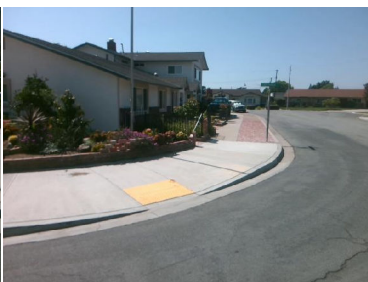
| Compliance | Description | Data | Compliance | Description | Data |
|---|---|---|---|---|---|
| <b>No</b> | Ramp Cross Slope (%) | <b>2.6</b> | <b>N/A</b> | Flare Traversable LT | <b>N/A</b> |

**Remove & Replace Curb Ramp With Two New Directional Ramps or Equivalent.**
