# Access Compliance Report Public Rights-of-Way (Curb Ramps)

| Main Street: TUNISIA_CIR | | Cross Street: CARTHAGE_ST | | Location: | NW |
| ADA ID: RPAT210917135221 | Ramp Type:Type 1 - Perpendicular | Initial Pass/Fail: Fail | Overall Compliance: No | Severity Score: | 2 |

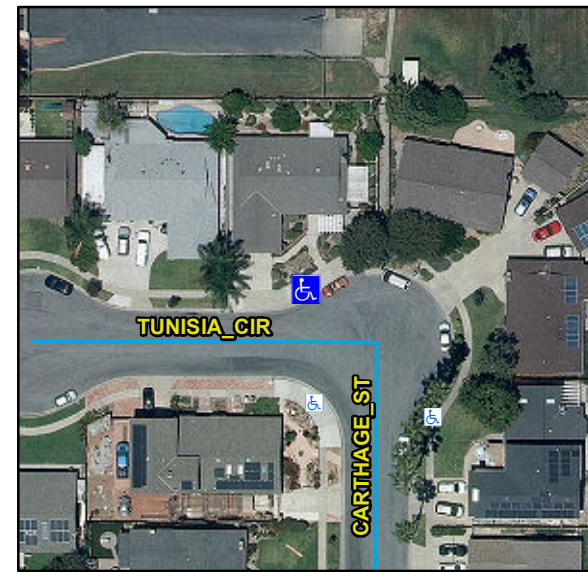
| Compliance | Description | Data | Compliance | Description | Data |
|---|---|---|---|---|---|
| No | Ramp Cross Slope (%) | 2.2 | N/A | Flare Traversable LT | N/A |

Possible Solutions:

**Remove & Replace Entire Ramp.**

**R304.2.2, R304.5.3, STD 1115**
