# Access Compliance Report Public Rights-of-Way (Curb Ramps)

Main Street: CAIRO\_CIR Cross Street: CARTHAGE\_ST Location: NW

ADA ID: RPAT210917140046 Ramp Type: Type 1 - Perpendicular Diagonal Initial Pass/Fail: Pass Overall Compliance: No Severity Score: 0

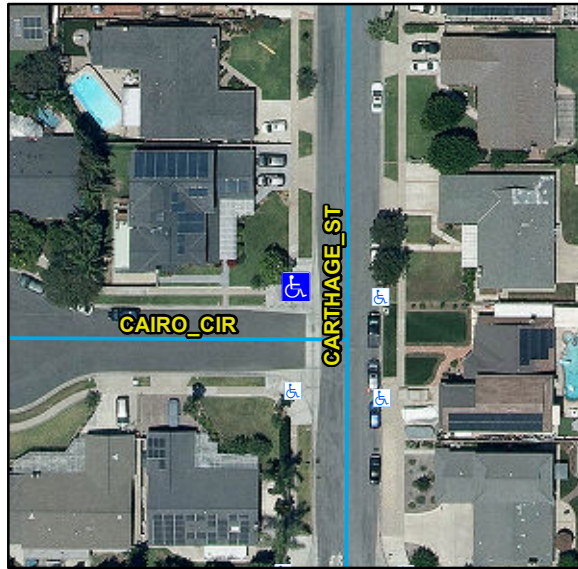
| Compliance | Description | Data | Compliance | Description | Data |
|---|---|---|---|---|---|
| Yes | Gutter Ponding | No | No | Curb Slope | 6.2 |

Remove & Replace Curb Ramp With Two New Directional Ramps or Equivalent.

R304.2.2, R304.2.1, STD 1115
